INDOOR AIR QUALITY ASSESSMENT

**White Street Elementary School
300 White Street
Springfield, Massachusetts**

Prepared by:
Massachusetts Department of Public Health
Bureau of Environmental Health Assessment
January, 2002

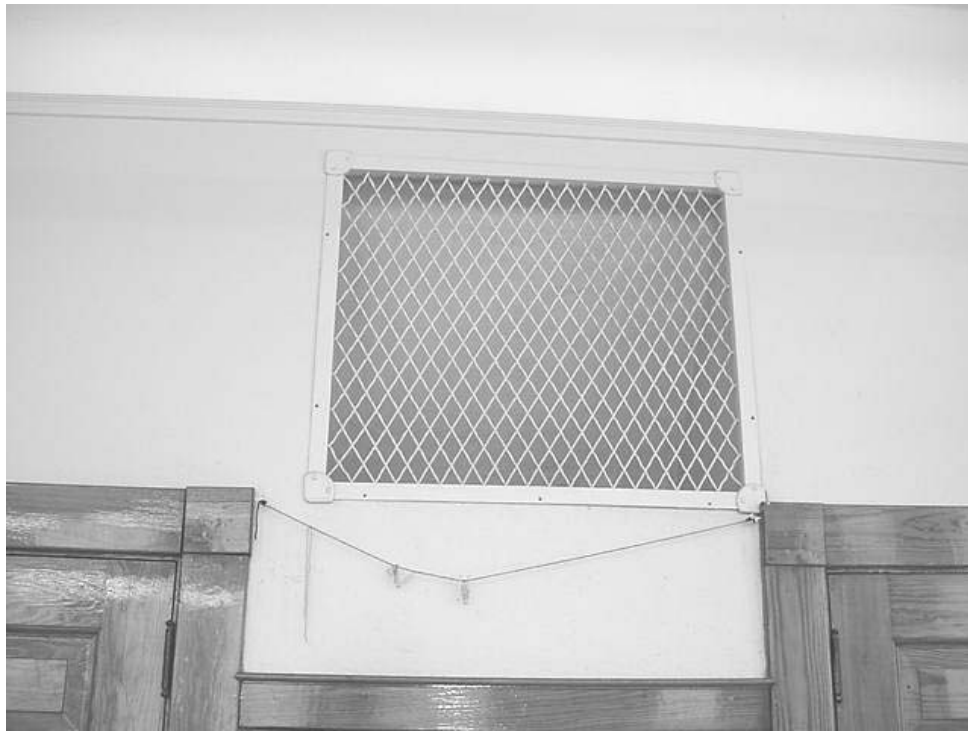
Picture 1

room on the ground floor that is connected to ductwork leading to air diffusers (see Pictures 1-3). Fresh air is drawn into the building through a vent at the rear of the building. Air is drawn through heating elements into a fan unit that distributes the air via wall mounted fresh air grilles throughout the 1906 section. Classroom fresh air supply grilles are connected to the fan unit by ductwork located in a crawlspace beneath the 1906 section. The fan was not operating during the assessment. In addition, some of the vents were sealed and many were missing or had damaged control mechanisms. The vault at the base of the ventilation shaft was being used as storage.

Supply Vent for Abandoned Mechanical Ventilation System in 1906 Building

2. Examine the feasibility of providing mechanical supply and exhaust ventilation in the original building. Determine if existing airshafts, vents, ductwork, etc. can be retrofitted for (modern) mechanical ventilation.

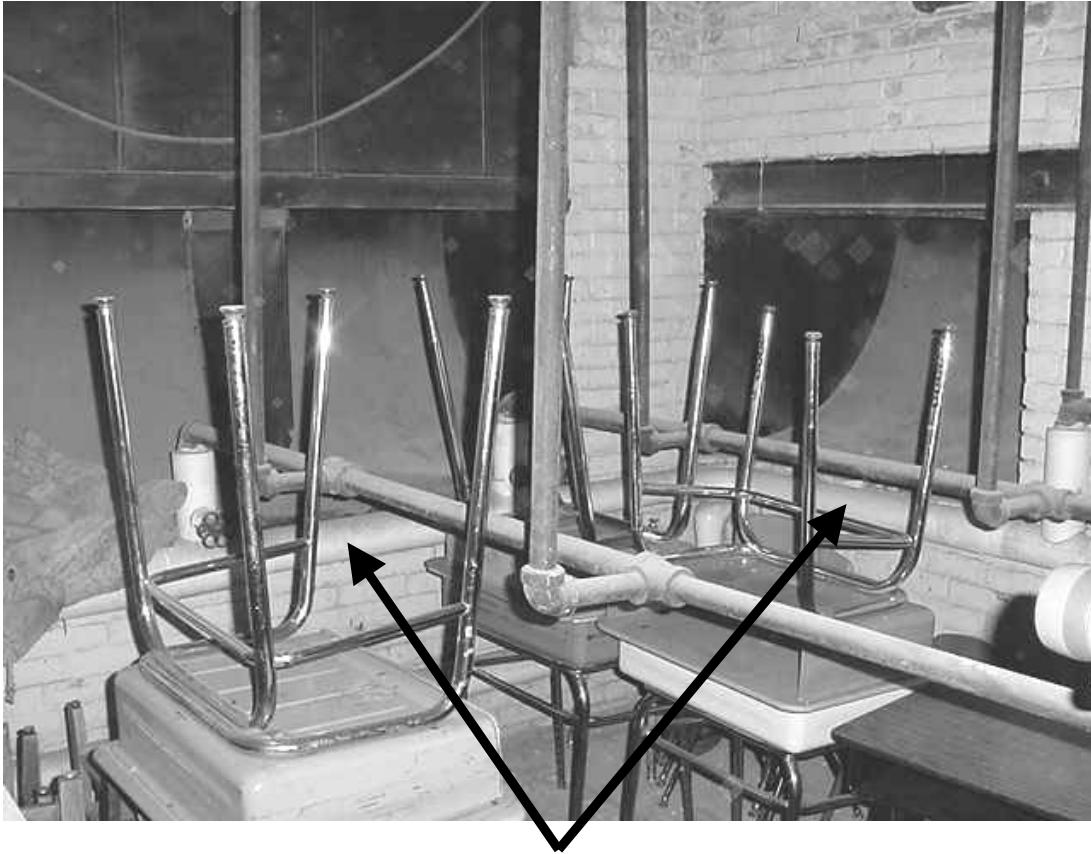
Picture 2

Ventilation Shafts in Basement, Area Now Used for Storage

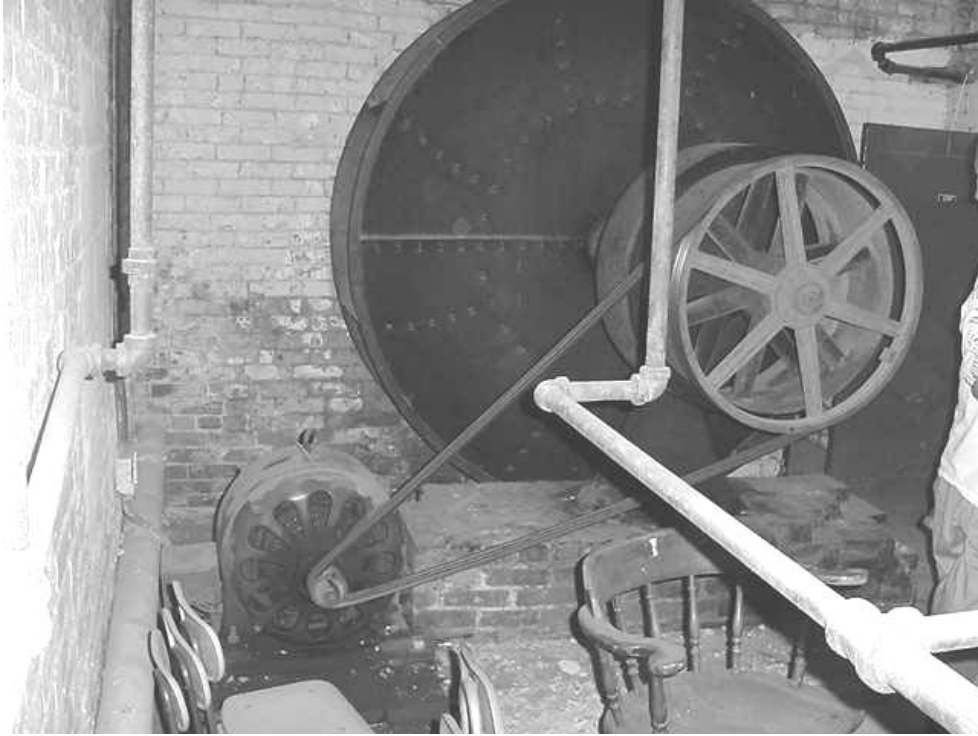
Picture 3

Fan for Mechanical Ventilation System in the 1906 Building

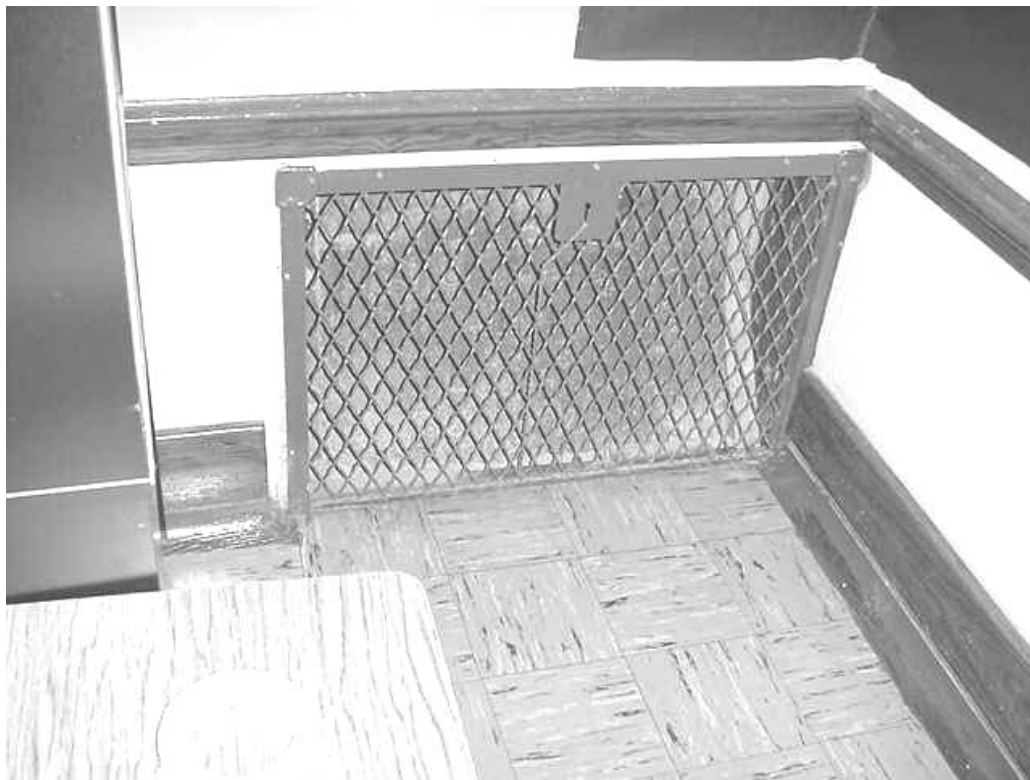
Picture 4

A corresponding vent exists in each room (see Picture 4) near the classroom doorway that is connected to an exhaust ventilation shaft which runs from the roof to the basement. Classrooms were constructed around these shafts to provide exhaust ventilation.

Supply Vent for Abandoned Mechanical Ventilation System in the 1906 Building

5. If original mechanical ventilation systems are not fully restored in the original building, ensure abandoned exhaust and supply vents are properly sealed to eliminate pathways for movement of odors and particulates into occupied areas.

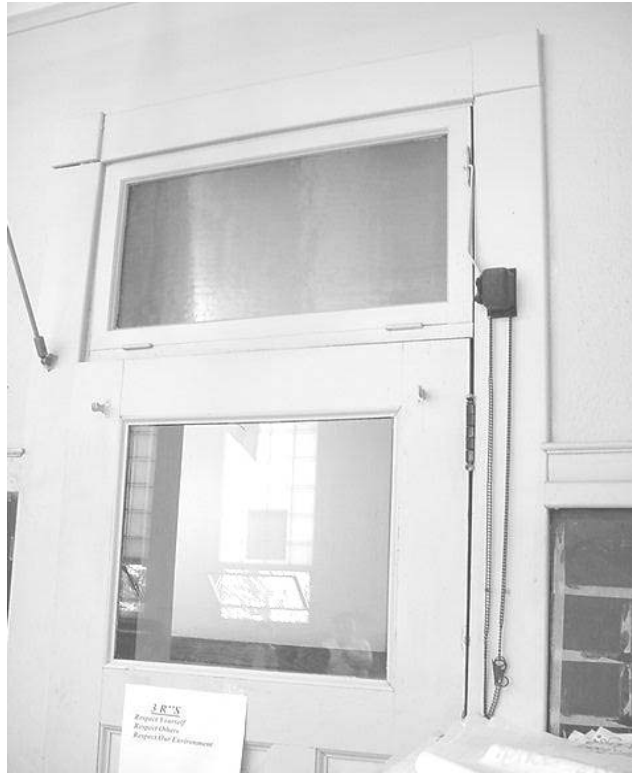
Picture 5

This building was configured in a manner to use cross-ventilation to provide comfort for building occupants. The building is equipped with windows on opposing exterior walls with hinged windows located above the hallway doors. This hinged window (called a transom) (see Picture 5) enables classroom occupants to close the hallway door while maintaining a pathway for airflow. The design allows for airflow to enter an open window, pass through a classroom and subsequently pass through the open transom. Airflow then enters the hallway, passing through the opposing open classroom transom, into the opposing classroom and finally exits the building on the leeward side (opposite the windward side) (see Figure 1). With all windows and transoms open, airflow can be maintained in a building regardless of the direction of the wind. This system fails if the windows or transoms are closed (see Figure 2). Transoms are opened using a chain/pulley system, some of which appeared operable.

Transom/Window System in 1906 Building, Note Pull Chain Mechanism on Side

3. Consider restoring/repairing transoms to working order to enhance airflow during warm weather. Be sure to close transoms at the end of the school day. To aid in the draw of fresh outdoor air in warm weather, use portable fans directing air out windows on the leeward side of the building. Fans positioned in this manner will serve to increase the draw of outdoor air across a floor without interfering with the natural internal airflow pattern of the building. To aid cross ventilation, open hallway doors in areas with inoperable transoms.

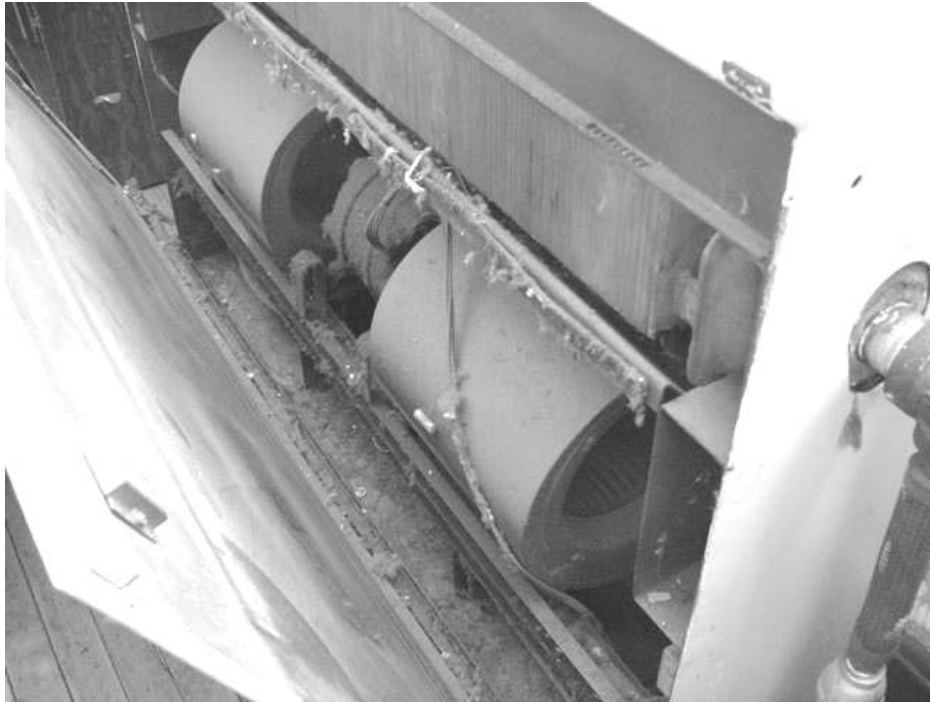
Picture 6

Fresh air in classrooms of this building is supplied by a unit ventilator (univent) system (see Picture 6). Univents draw air from outdoors through a fresh air intake located on the exterior walls of the building (see Picture 7) and return air through an air intake located at the base of each unit (see [Figure 3](#)). Fresh air and return air are mixed, filtered, heated and provided to classrooms through a fresh air diffuser located in the top of the unit.

classrooms. To function as designed, univents and univent returns must remain free of obstructions. Importantly, these units must be activated and allowed to operate during hours of school occupation. Univents appear to be original equipment (possibly greater than 60 years old). Univents were opened in several classrooms. None of the univents inspected contained filters (see Picture 6).

A number of univents had accumulated dirt, dust and debris within their air handling chambers, on coils, fans and other components (see Picture 6). These conditions can be attributed to the fact that no means for inserting filters exist in these univents. In order to avoid univents serving as a source of aerosolized particulates, the air handling sections of the univents should be regularly cleaned. However, without filters, dirt, dust and debris can easily collect within the units.

Interior of 1934 (Annex) Building Univent, Note Lack of Filter and Accumulation of Dirt, Dust and Debris

2. Remove all blockages from univents to ensure adequate airflow. Clean out interiors of univents regularly. Have univents examined by an HVAC engineering firm to determine if univents can be fitted for filters.

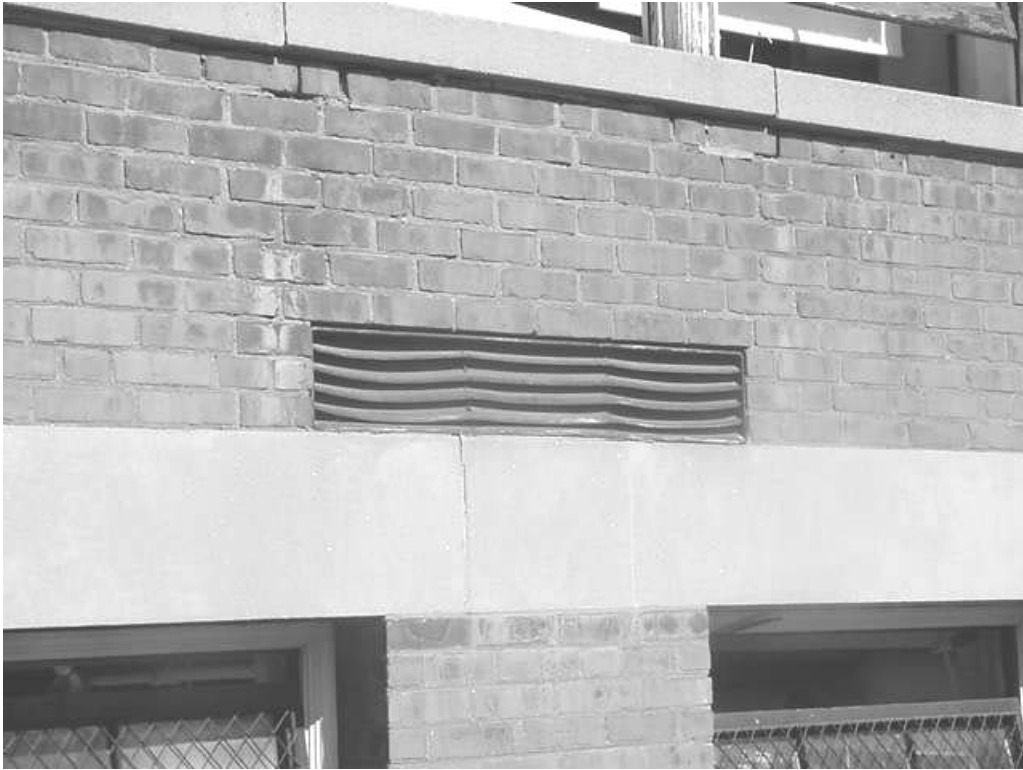
Picture 7

Univent Fresh Air Intake

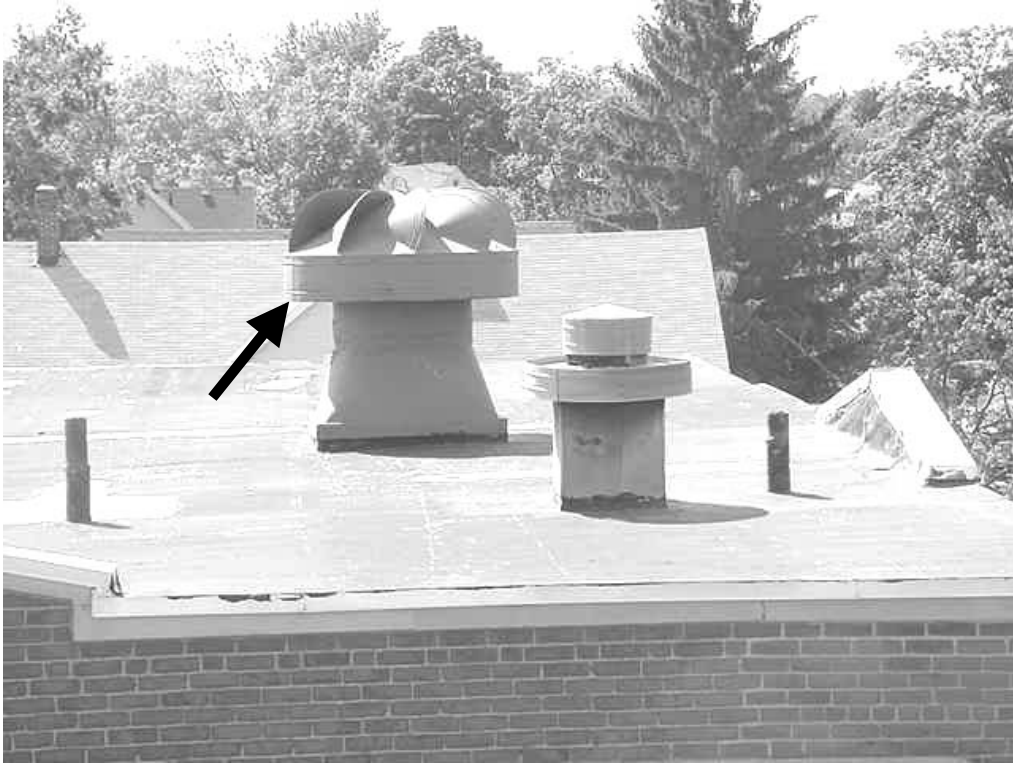
Picture 8

Exhaust ventilation for this wing consists of non-mechanical exhaust vents located at floor level that are connected by ductwork to wind driven turbine propelled fans on the roof (see Picture 8). Although roof turbines were freely rotating, no draw of air was noted in classrooms, indicating possible blockage of airflow. Mr. Murphy indicated that this was most likely caused by a fault in the flue system, which was inoperable. Without exhaust ventilation, environmental pollutants can build up in the indoor environment and lead to indoor air quality complaints.

Wind-Driven Turbine Exhaust Vent on 1934 (Annex) Building Roof

3. Have HVAC engineer examine exhaust vents in the annex for function and activate if operable.
4. To maximize air exchange, the BEHA recommends that the ventilation system operate continuously during periods of school occupancy independent of classroom thermostat control.

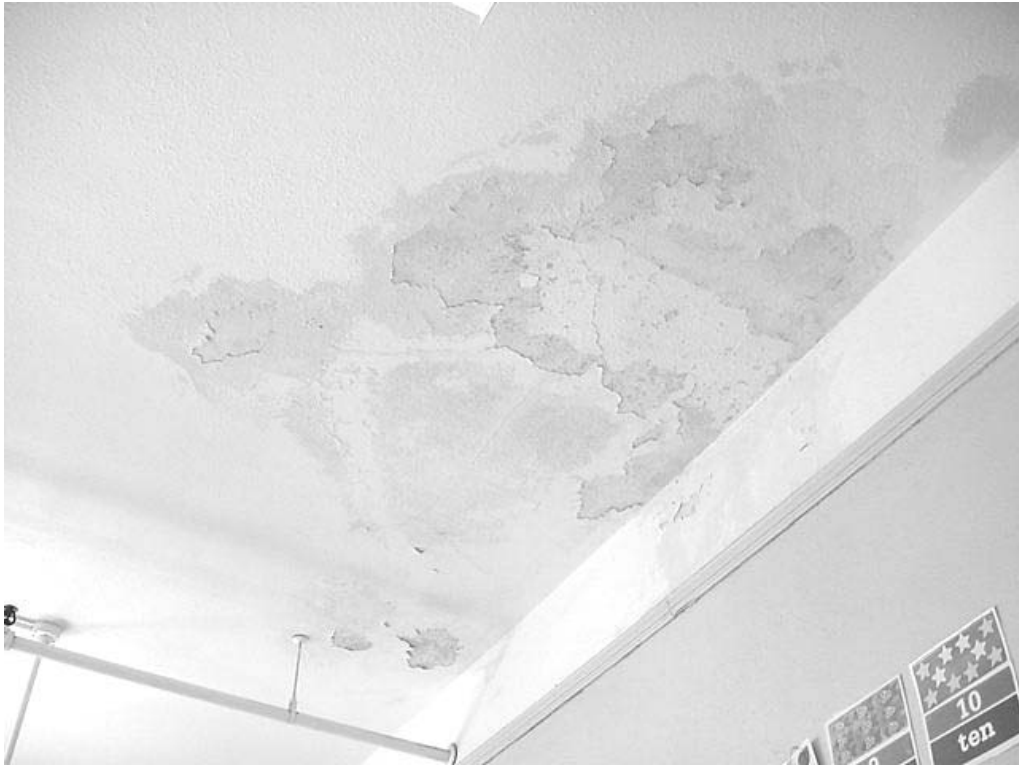
Picture 9

Water-damaged ceiling tiles and wall plaster were observed in several areas of both buildings (see Picture 9), which indicates a current or historic water penetration problem. Efflorescence (i.e., mineral deposits) was observed in room B-4 of the original building. Efflorescence is a characteristic sign of water damage to building materials such as brick or plaster, but it is not mold growth. As moisture penetrates and works its way through mortar around brick, water-soluble compounds in bricks and mortar dissolve, creating a solution. As the solution moves to the surface of the brick or mortar, water evaporates, leaving behind white, powdery mineral deposits. This condition indicates that water from the exterior has penetrated into the building. Water damaged building materials such as wall plaster and ceiling tiles can serve as a medium to support mold growth, especially if wetted repeatedly. Active roof leaks were reported in classroom 18 of the annex.

Water-Damaged Ceiling Plaster and Peeling Paint

5. Repair any existing water leaks and replace any remaining water-stained ceiling tiles, wooden windowsills and wood trim. Examine the areas above and around these areas for mold growth. Disinfect areas of water leaks with an appropriate antimicrobial as needed.

7. Consider having exterior brick repointed and waterproofed to prevent further water intrusion. Repair/replace water-damaged plaster. Examine surrounding non-porous areas for mold growth and disinfect with an appropriate antimicrobial if necessary.

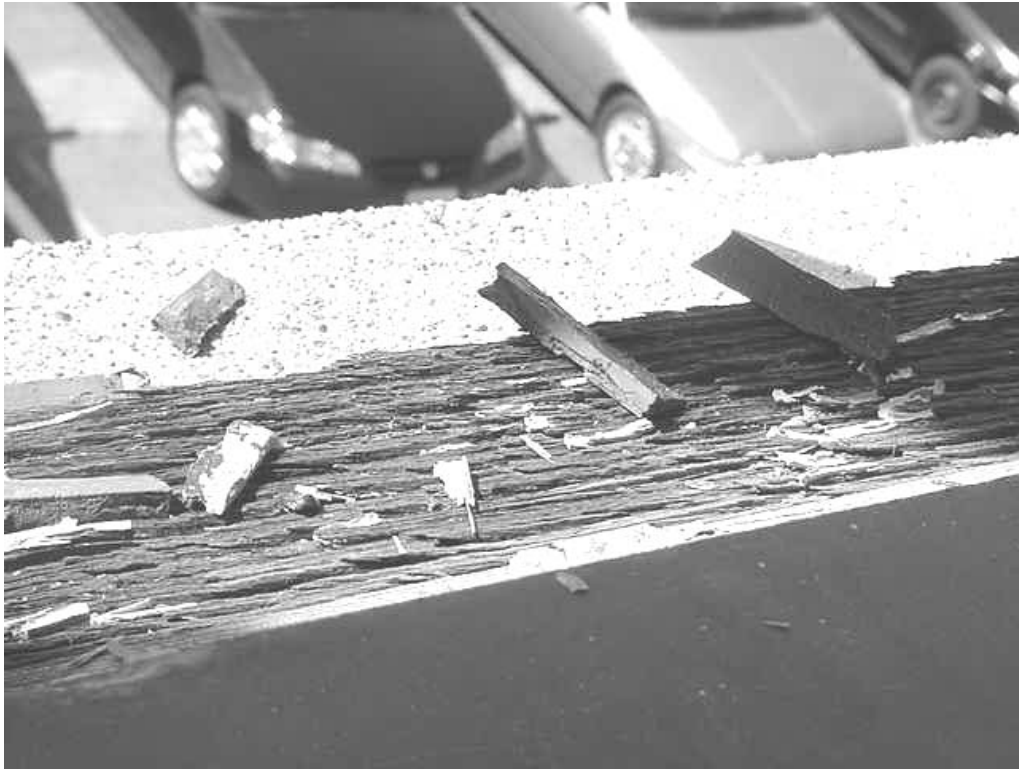
Picture 10

Of particular note are the conditions of caulking of windowpanes in the annex. Caulking around the interior and exterior of windowpanes is crumbling, missing or damaged throughout the building (see Picture 10). A broken window was noted in classroom 16 and spaces were noted around the window in the first floor reading room (see Picture 11). Many of these rooms had water-damaged windowsills and wall plaster, which is evidence of water intrusion through improperly sealed windows. Repeated water damage can result in mold colonization of the wooden window frames and porous materials. Once mold has colonized these materials, they are difficult to clean and should be replaced.

Pieces of Damaged Window Caulking on Water Damaged Window Sill in 1934 (Annex) Classroom

6. Replace missing or damaged window caulking building-wide (annex) to prevent water penetration through window frames.

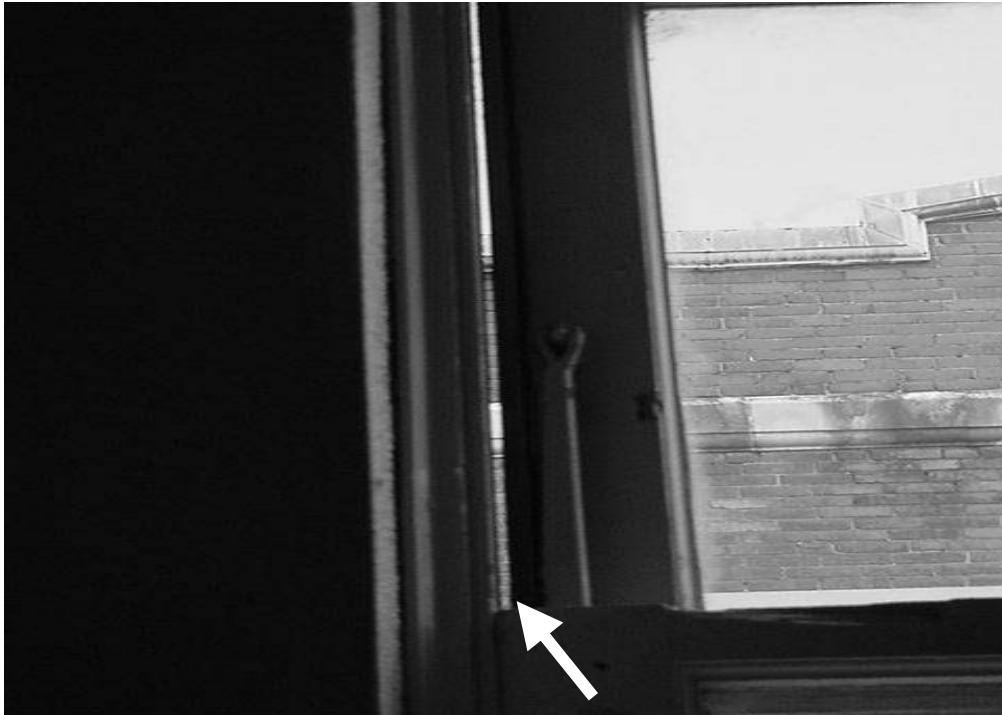
Picture 11

**Spaces around Window in First Floor Reading Room of 1934 (Annex) Building,
Note Window was Closed at Time of Photo**

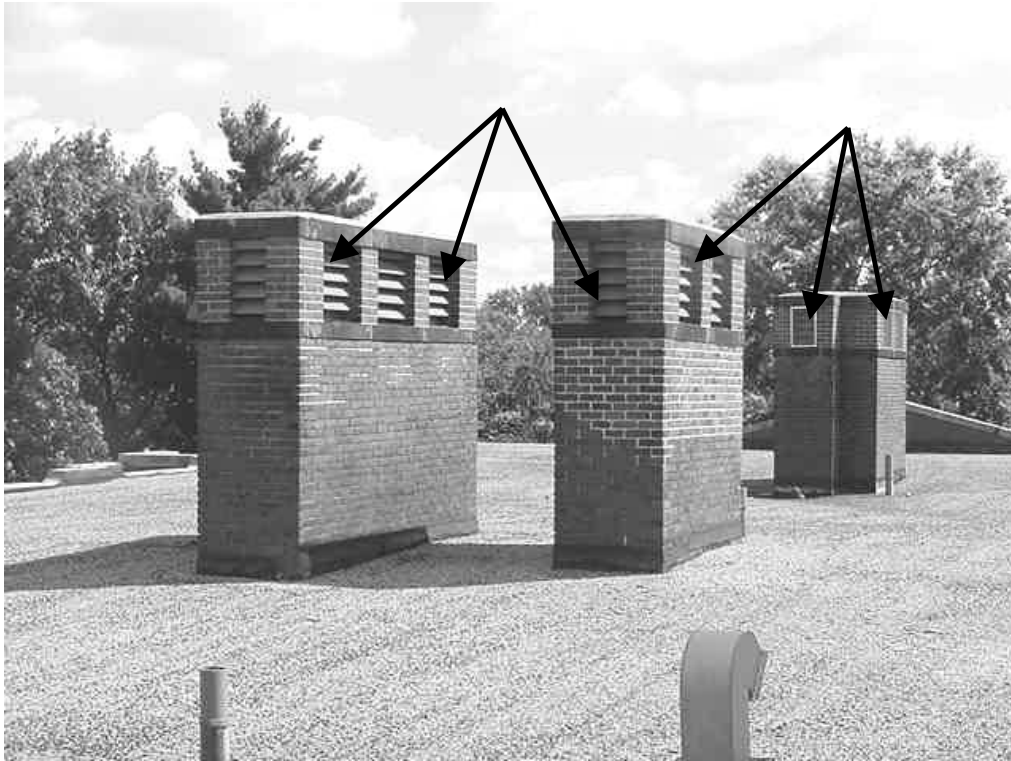
Picture 12

Building staff reported the occasional sound of birds within abandoned ventilation shafts. No obvious evidence of bird infestation was observed in classroom vents during the assessment (e.g., feathers, wastes, nesting materials). BEHA staff examined conditions on the roof for potential pathways of egress for birds into the building. Ventilation shafts terminate on the roof through louvered vents (see Picture 12). While some of the vents were secured with wire mesh to prevent bird egress, several vents were missing screens.

Rooftop Exhaust Vents, Many of which were not Secured with Wire Mesh to Prevent the Occupation of Birds/Pests

8. Ensure exhaust ventilation shafts are properly secured with screens on the roof of the original building and inspect periodically to prevent occupation by birds and other pests.

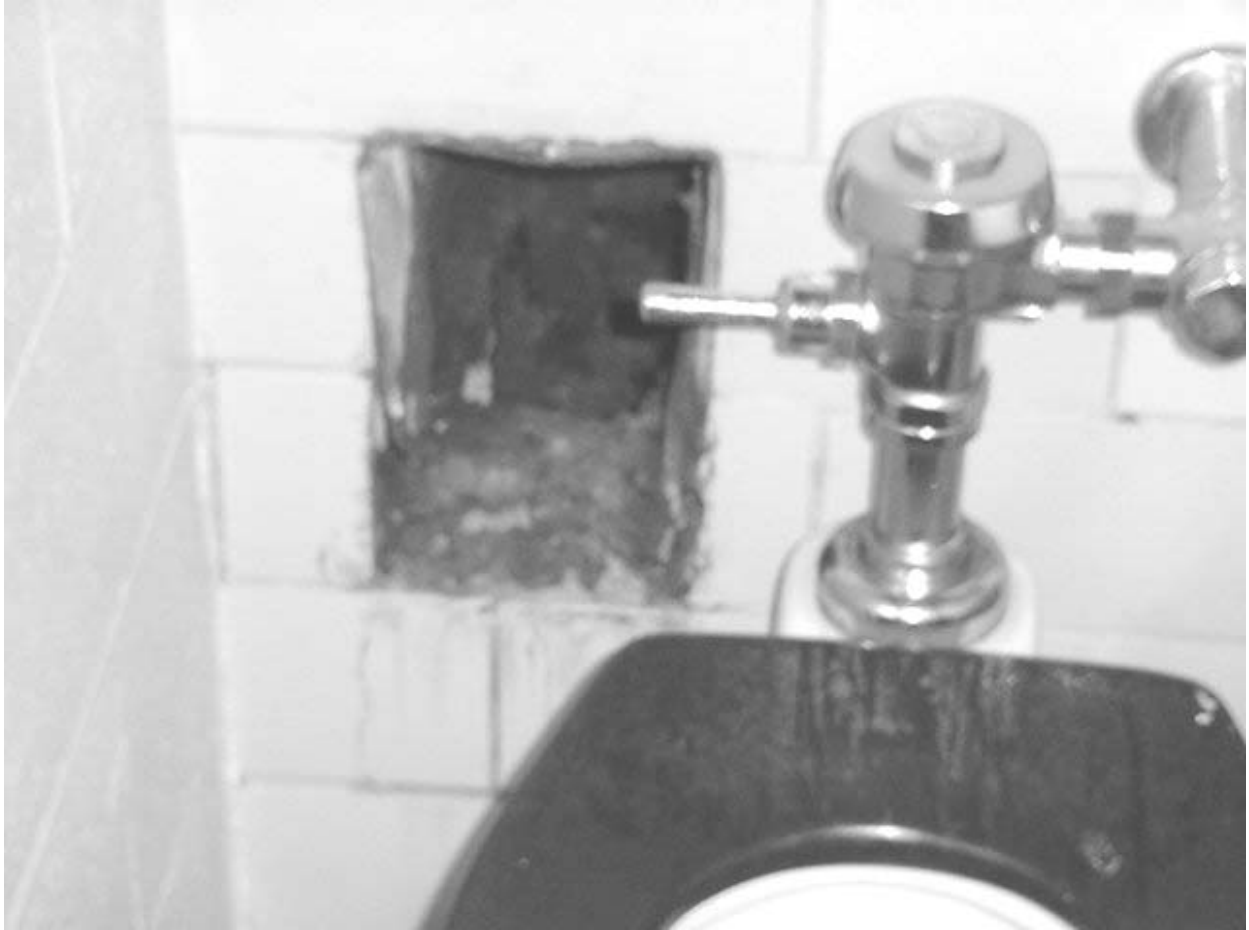
Picture 13

Mechanical exhaust ventilation in some restrooms was not functioning during the assessment. The vent in the basement restroom of the original building had corroded to the point of disintegration (see Picture 13). Exhaust ventilation is necessary in restrooms to remove moisture and to prevent restroom odors from penetrating into adjacent areas.

Missing Exhaust Vent in Basement Restroom of the 1906 Building
